Residential Remedial Action Completion Report, West McComas Street Site, Baltimore, Maryland

Executive Summary

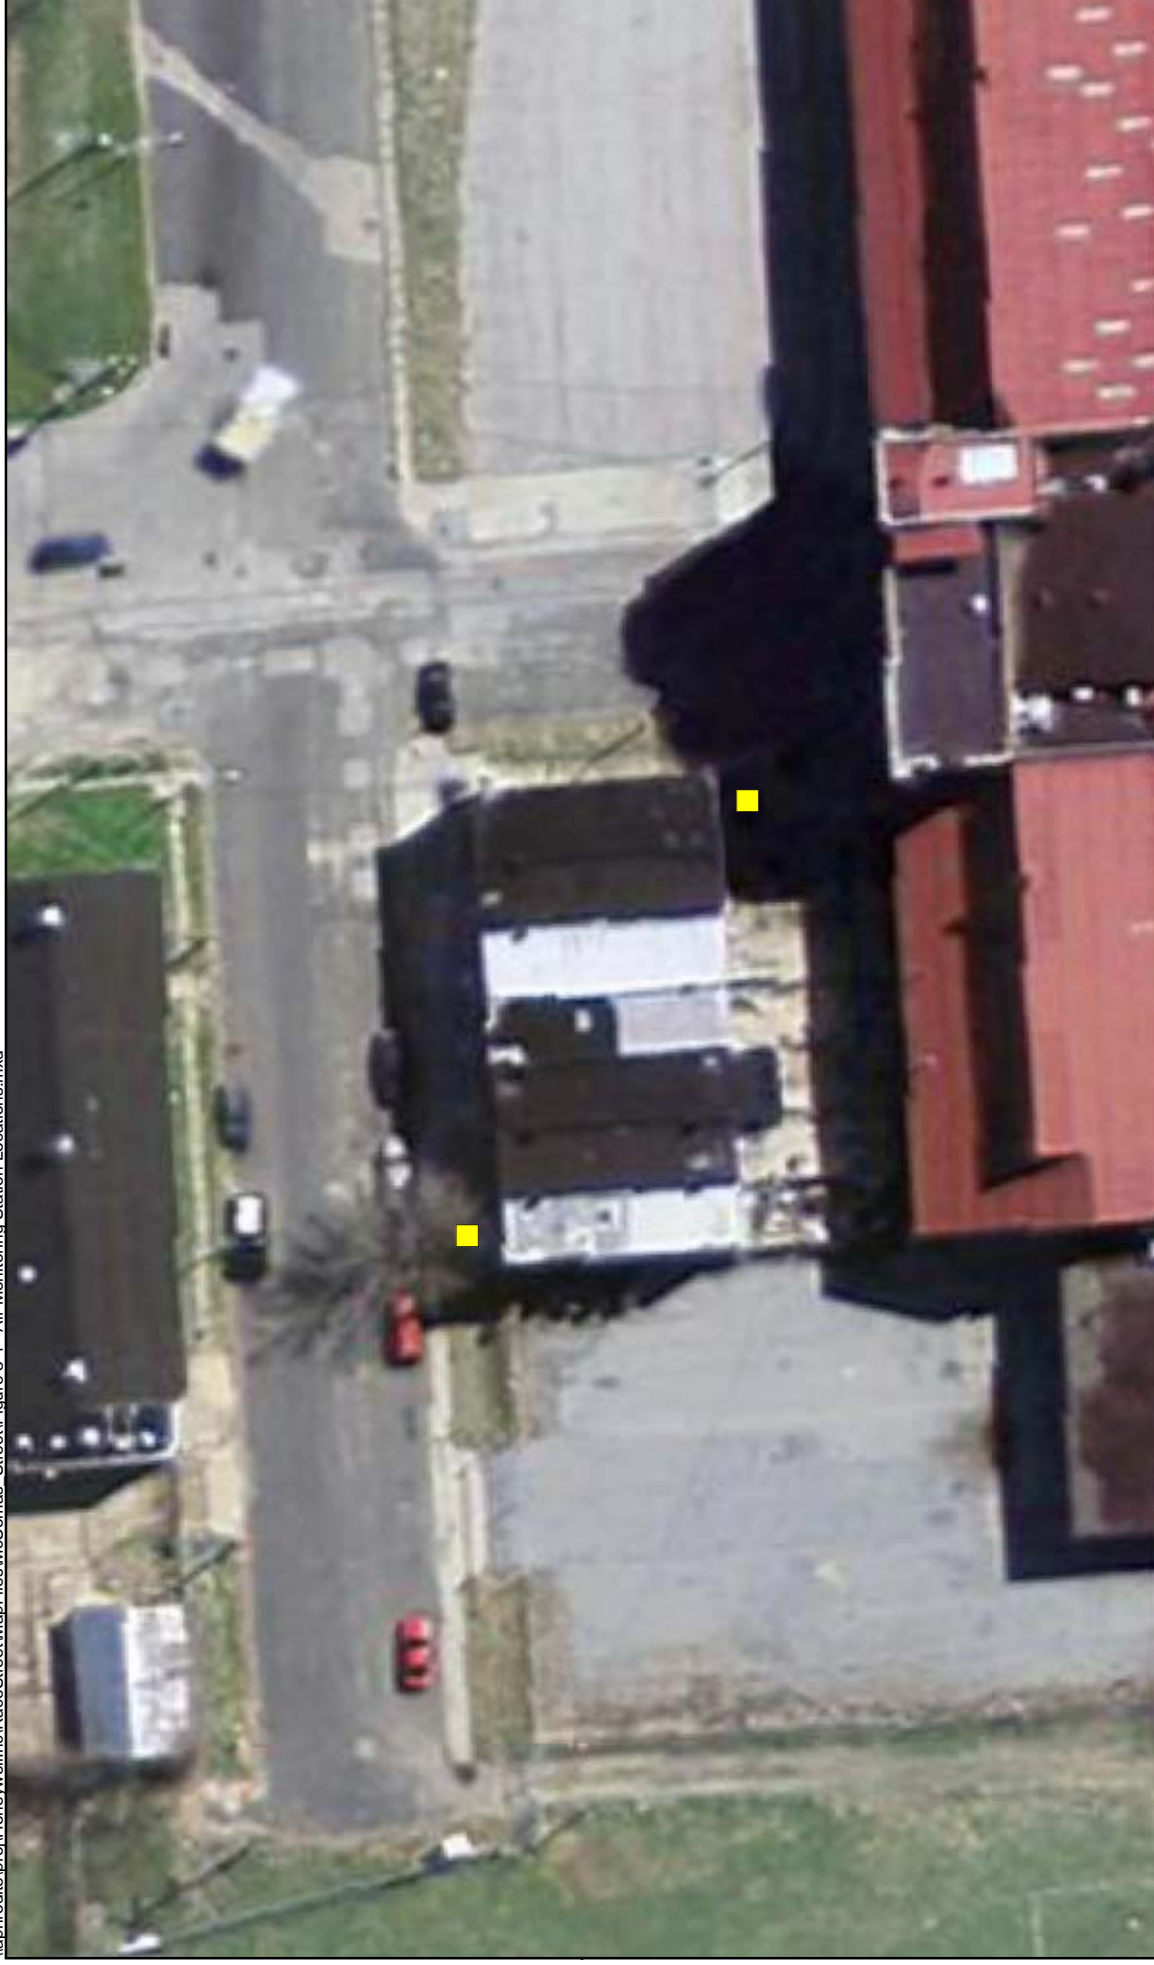
- Air Monitoring Locations

The particulate air monitors (e.g., DataRAM 4) were equipped with an omni-directional air intake device and a PM₁₀ impactor head to monitor dust levels throughout the entire 2-month period when active construction activities were performed. (The PM₁₀ monitors measure dust concentrations of particles less than 10 µm in diameter). Both air monitors were operated throughout each workday and were calibrated by the equipment manufacturer before being used at the site. Air monitoring was suspended only during periods of high humidity (e.g., fog and rain), since moisture entering the monitor can damage the unit. Operation of the monitors during humid site conditions can result in slightly higher values being recorded (false positives). These conditions were taken into consideration when the monitoring data are downloaded and reviewed. Table 3-1 presents the action levels for the McComas Street residential remediation project.

No elevated dust levels were detected during the soil excavation or other construction activities performed at the site. Furthermore, no single monitoring results exceeded the action level of 0 to 1 mg/m³ (or 1,000 µg/m³). A summary of the air monitoring data compiled from the air monitors are provided in Attachment D.
